SIO Shipyard Representative Bi-Weekly Progress Report		
Project: AGOR 28	Contract No.: N00014-12-C-0305	Shipyard: Dakota Creek Industries
Prepared by: Paul D. Bueren Scripps Institution of Oceanography (SIO) 297 Rosecrans St. San Diego, CA 98106	Date: 15 February, 2016	Program Officer: Robert (Tim) Schnoor Office of Naval Research 875 Randolph St ONR 321 Arlington, VA 22203-1995
Distribution Statement A: Approved for public release; distribution unlimited.		Report No. A002.094

Weekly Report 15 Feb 2016

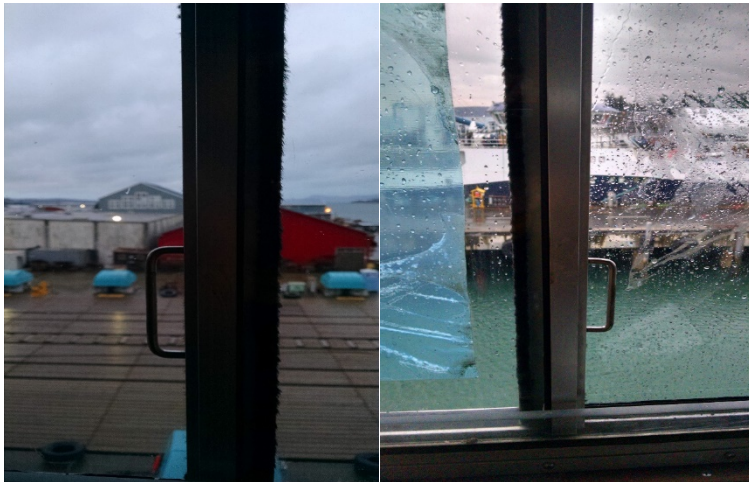
Handles for Bridge port and stbd side sliding windows reinstalled with better adhesive. Should be good now. Have to remember to lift up on handle before attempting to slide.

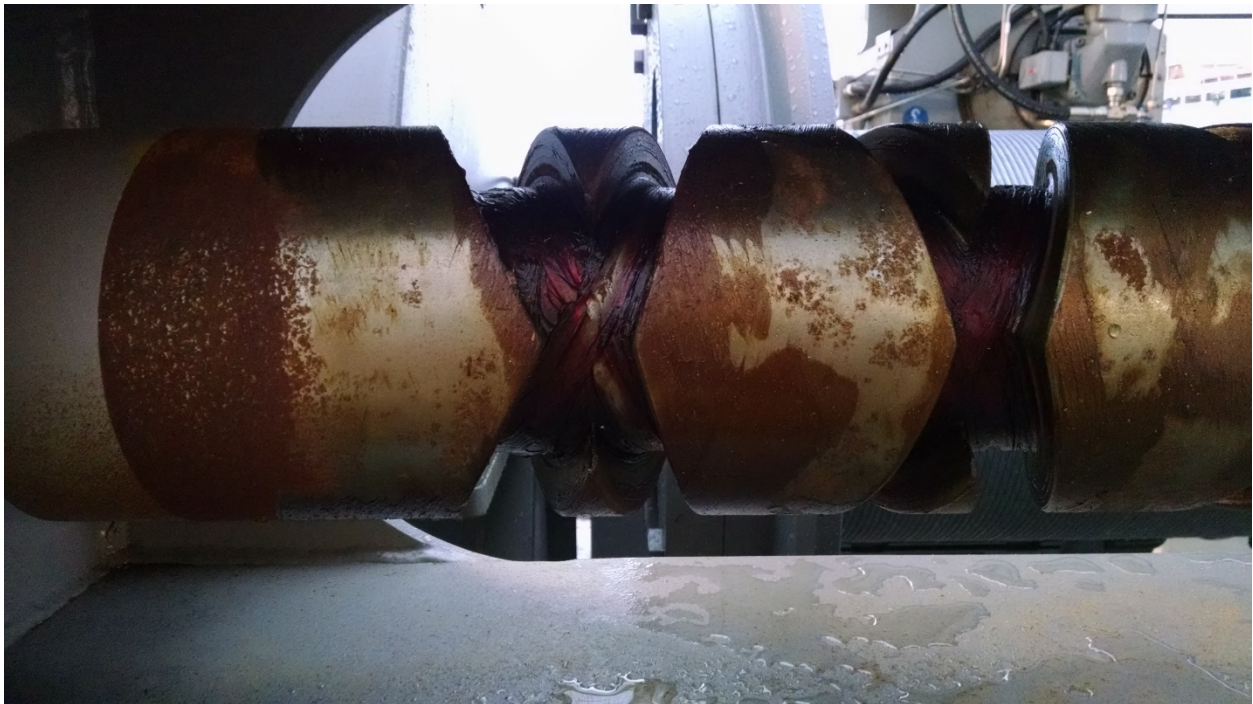
Level wind diamond screw for forward CAST 6 winch showing signs of light rust. Winch was tested some time ago, rust needs to be cleaned up and grease reapplied on both CAST 6 winches.

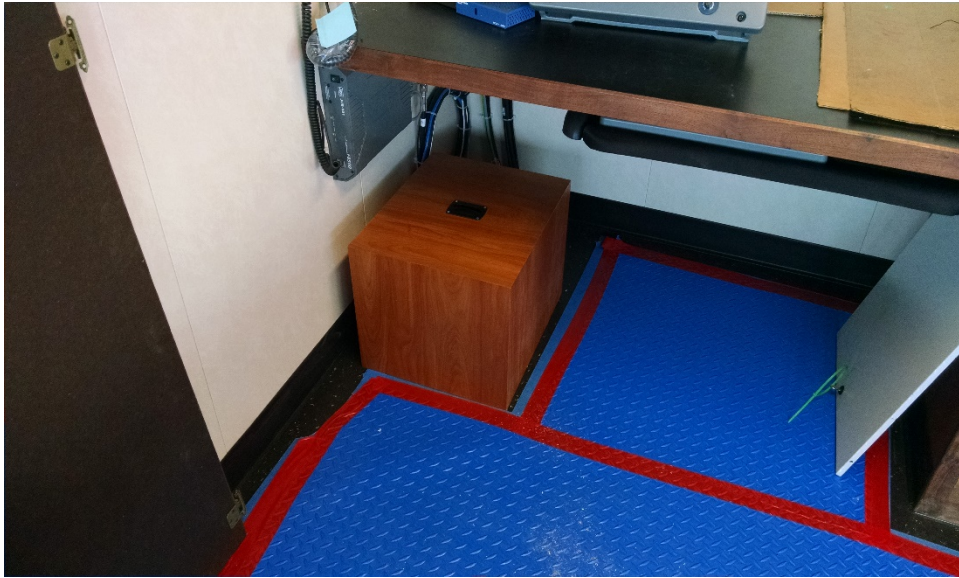
Kick hazard eliminated for the Chart room ECDIS...not exactly the way I would have done it but hard to argue effectiveness. Back side is open allowing for some ventilation. .

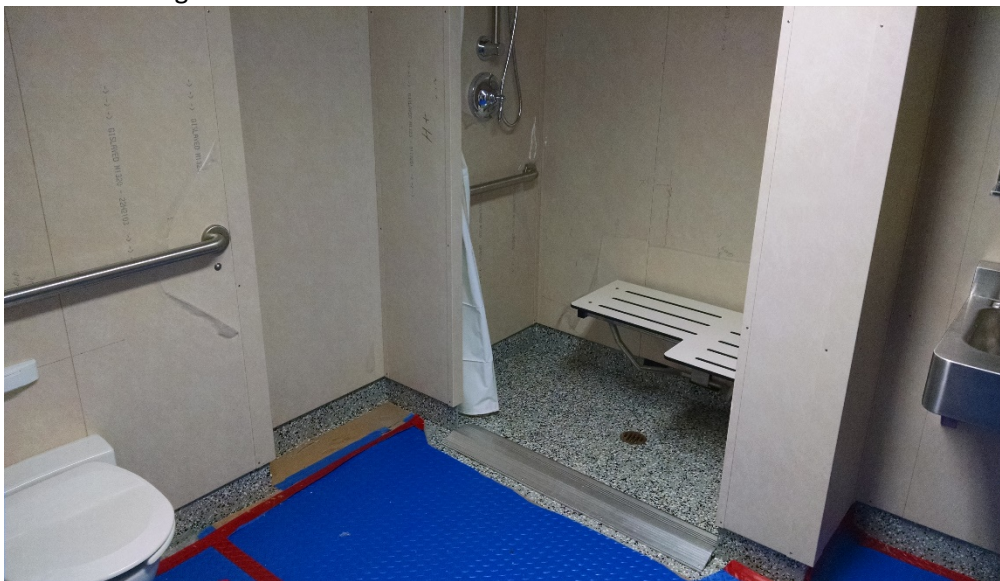
ADA head receiving the last of the installs.
